# **Case Study: How Recurring Oil Pan Cracks on Large High Speed Gas Engines were Investigated and Resolved**

2015 Gas Machinery Conference

The following case study illustrates issues with oil pans developing cracks shortly after being put into service on large, high-speed gas engines. Cracks developed on the bottom of several Williams' engine oil pans in late October 2014 after accumulating no more than 70 hours of run time. This prompted Williams, Caterpillar, and 6D Testing & Analysis to identify suspect oil pans and initiate an investigation. The process taken to identify the cause of the oil pan cracks including the details of the investigation, analyses, and test results are described in the following paper.

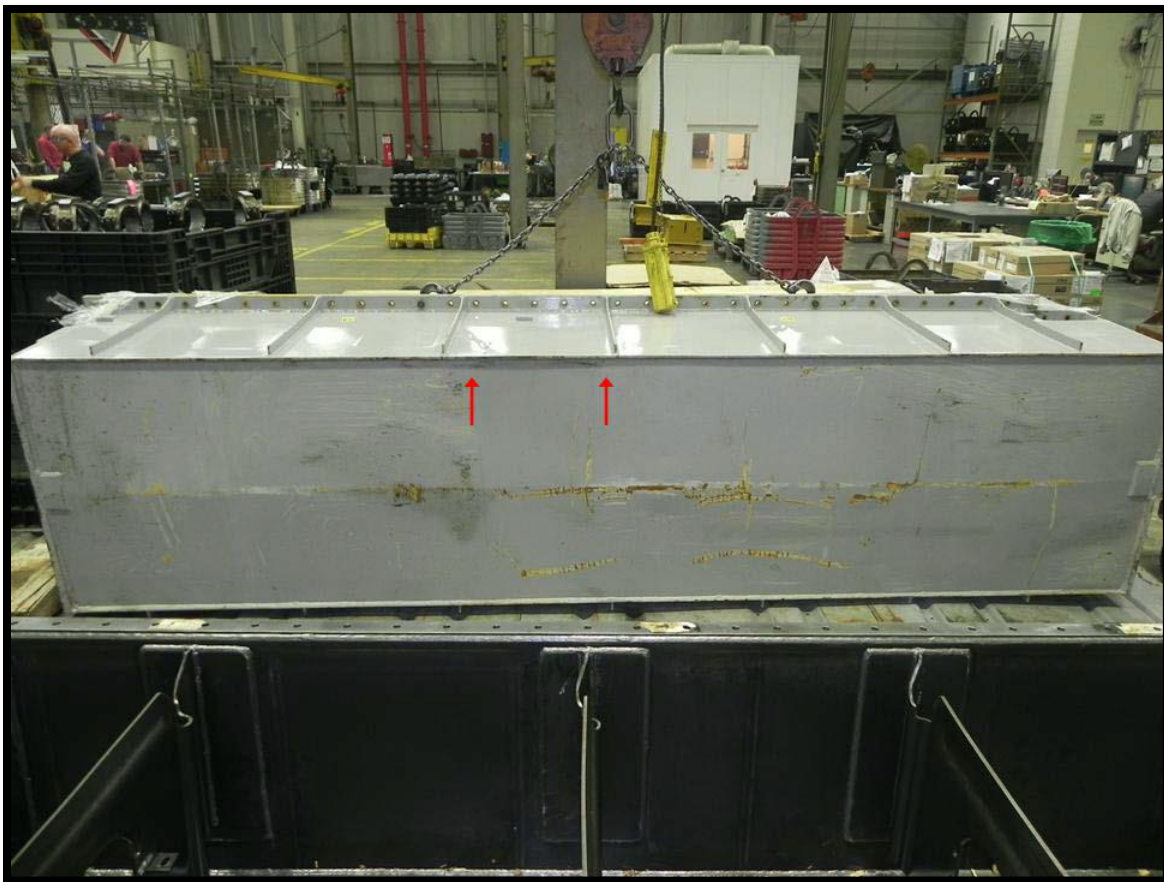
The first oil pan crack, shown in Figure 2, occurred in late 2014 after only 66 hours of operation. As shown in Figure 3Error! Reference source not found., the crack occurred on the bottom of the pan. Therefore, it was necessary for CAT and Williams to immediately remove the oil pan from the engine to be shipped to CAT for non-destructive testing (NDT) to assess the cause of the unexpected failure.

Figure 2: Crack on the Bottom of the Oil Pan

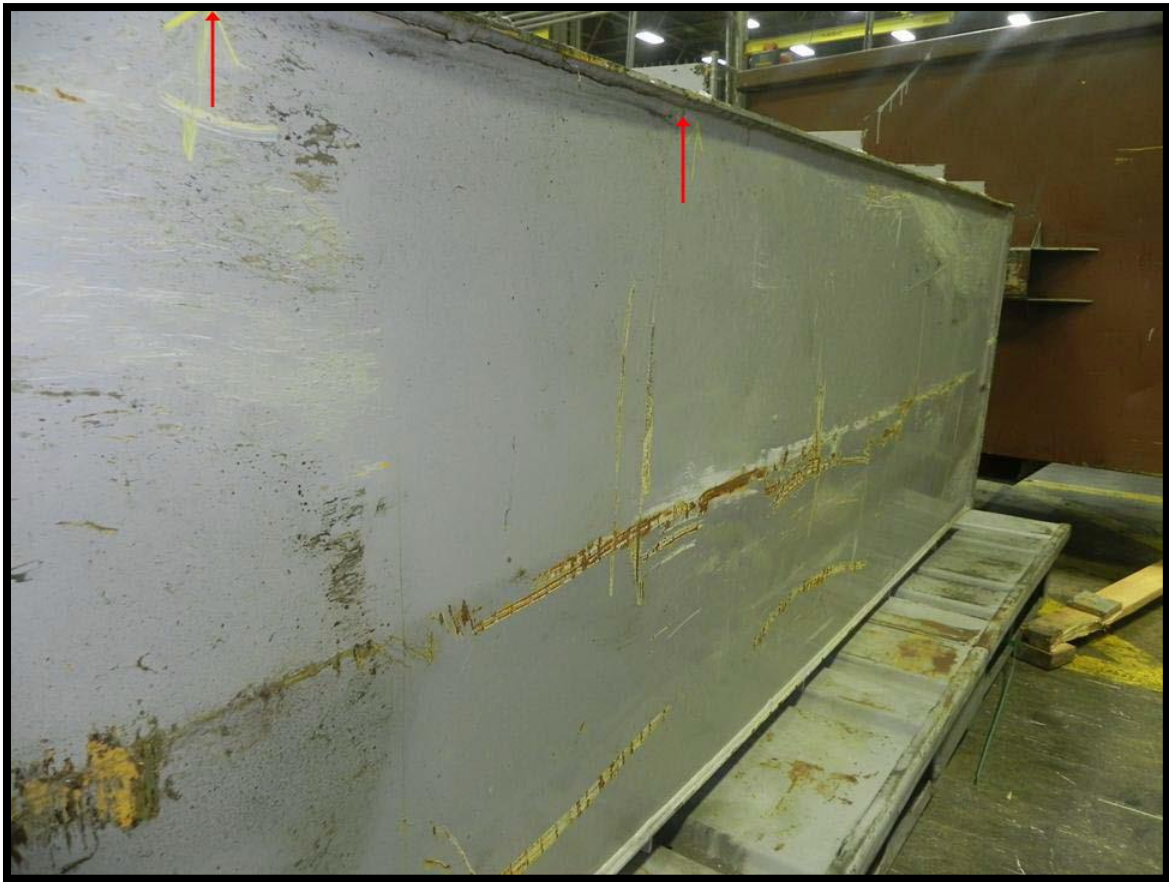
Figure 3: Location of the Crack

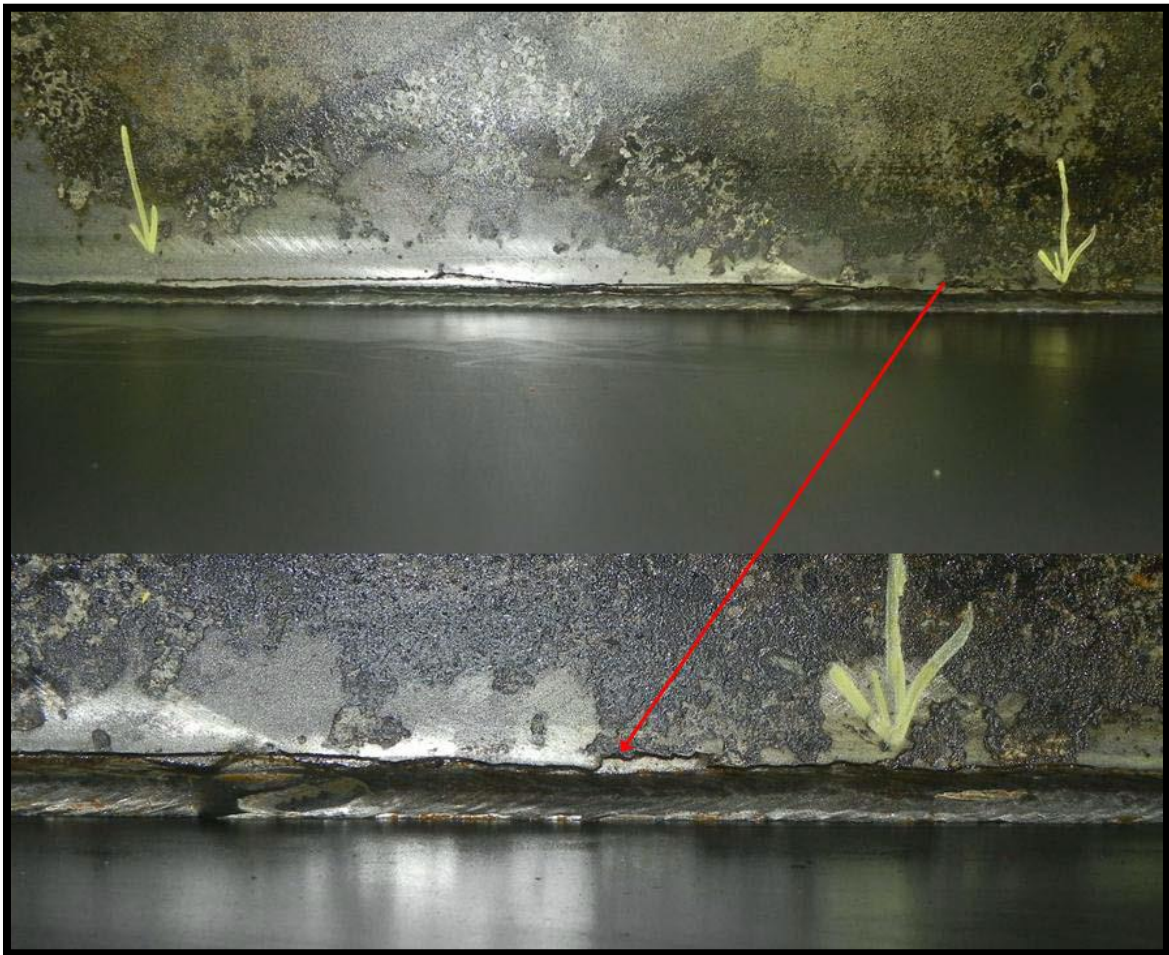
Inspection of the oil pan found a crack along the bottom plate of the oil pan, adjacent to the weld. The pan was sectioned and the crack was opened up to examine the fracture in detail.

Figure 6: Closer View of Crack

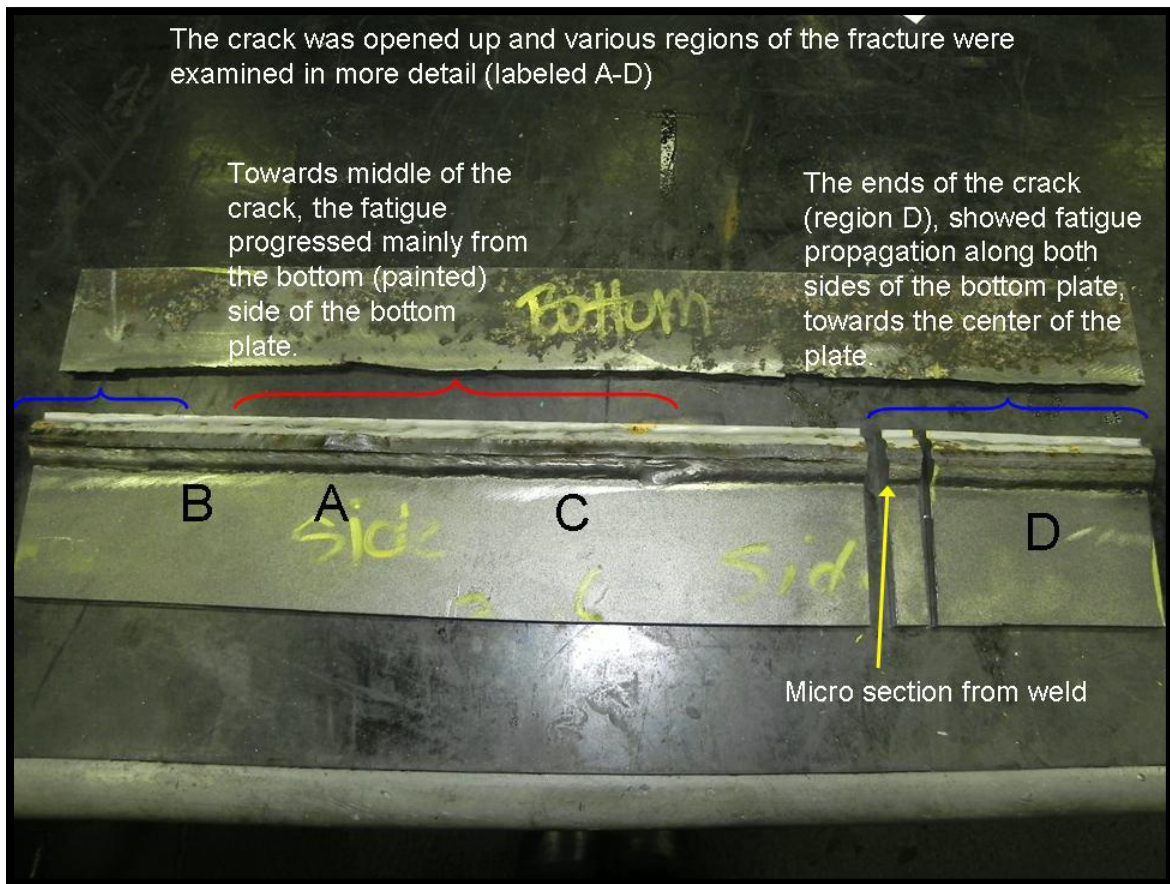
The pan was sectioned and the crack was opened up to examine the fracture surface, Figure 7.

Figure 7: Oil Pan Sectioned for Examination

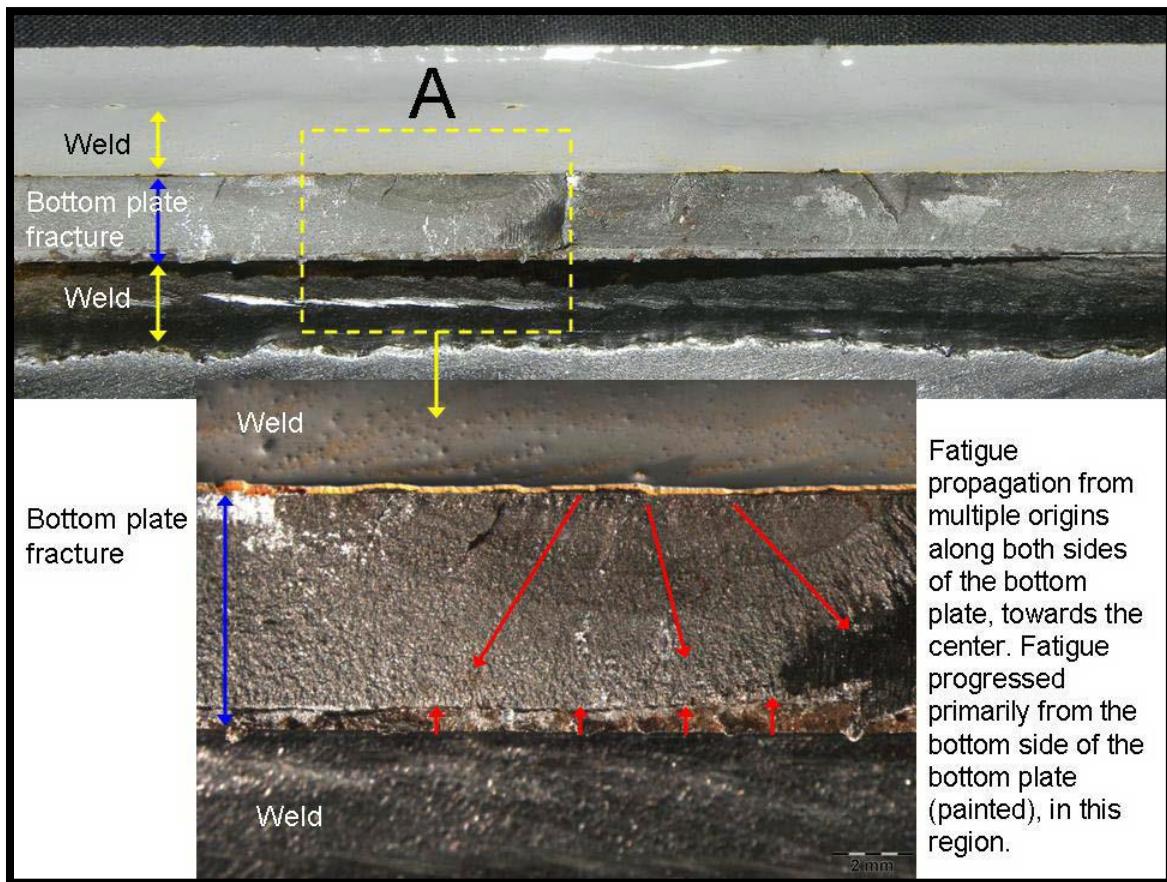
Towards the middle of the crack, fatigue from multiple origins propagated primarily from the bottom (painted) side of the bottom plate, Figure 8: Microscopic View of Fatigue Propagation. The ends of the crack showed fatigue propagation along both sides of the bottom plate, towards the center of the plate thickness. Microscope inspection of the weld near the crack and away from the crack showed good fusion, acceptable fillet leg and throat size, and no defects. Fatigue propagated from multiple origins along both sides of the bottom plate, towards the center of the plate. Fatigue progressed primarily from the bottom (painted side) of the bottom plate. This could indicate higher stress along the bottom side of the bottom plate.

Figure 8: Microscopic View of Fatigue Propagation

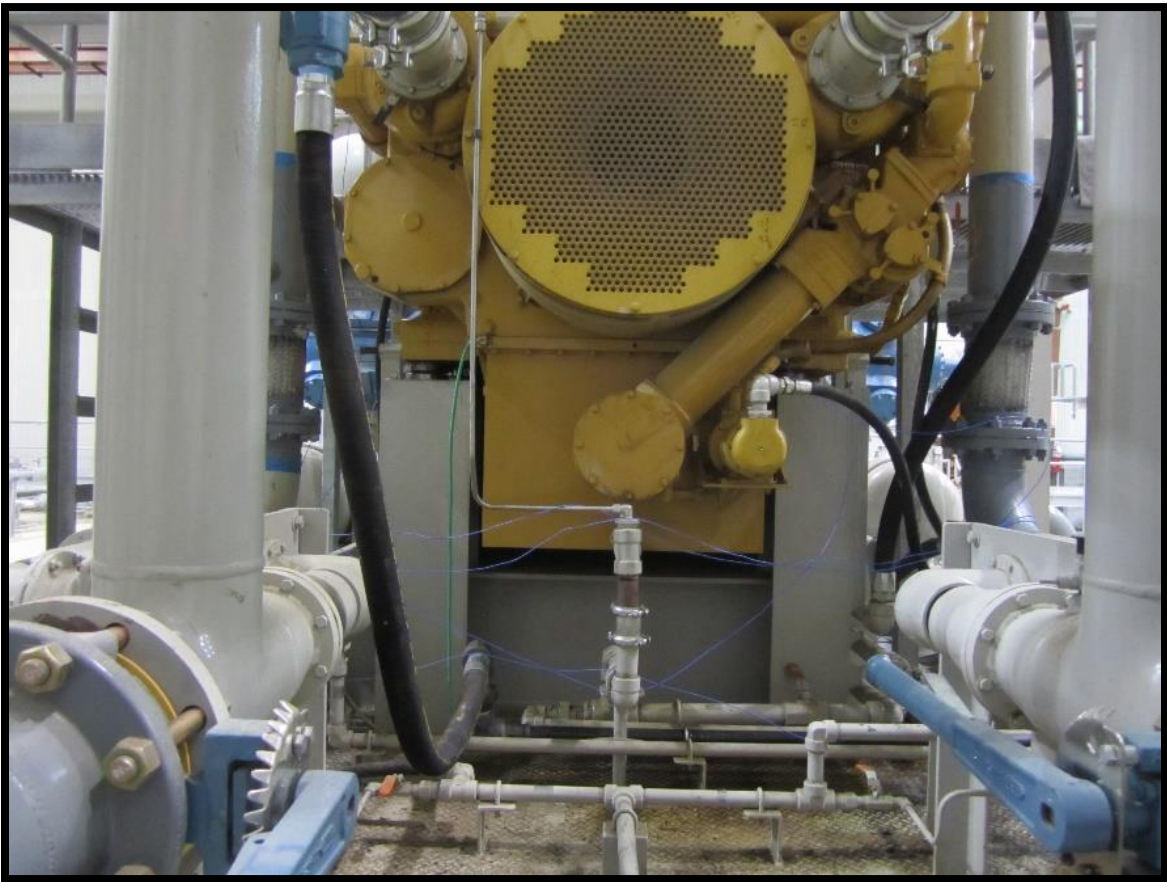
Unfortunately, access limitations did not allow for placing any instrumentation in the oil pan failure region. As shown in Figure 9, the gap between the bottom of the oil pan and the base structure did not provide sufficient space to install any instrumentation.

Figure 9: Limited Accessibility of Oil Pan

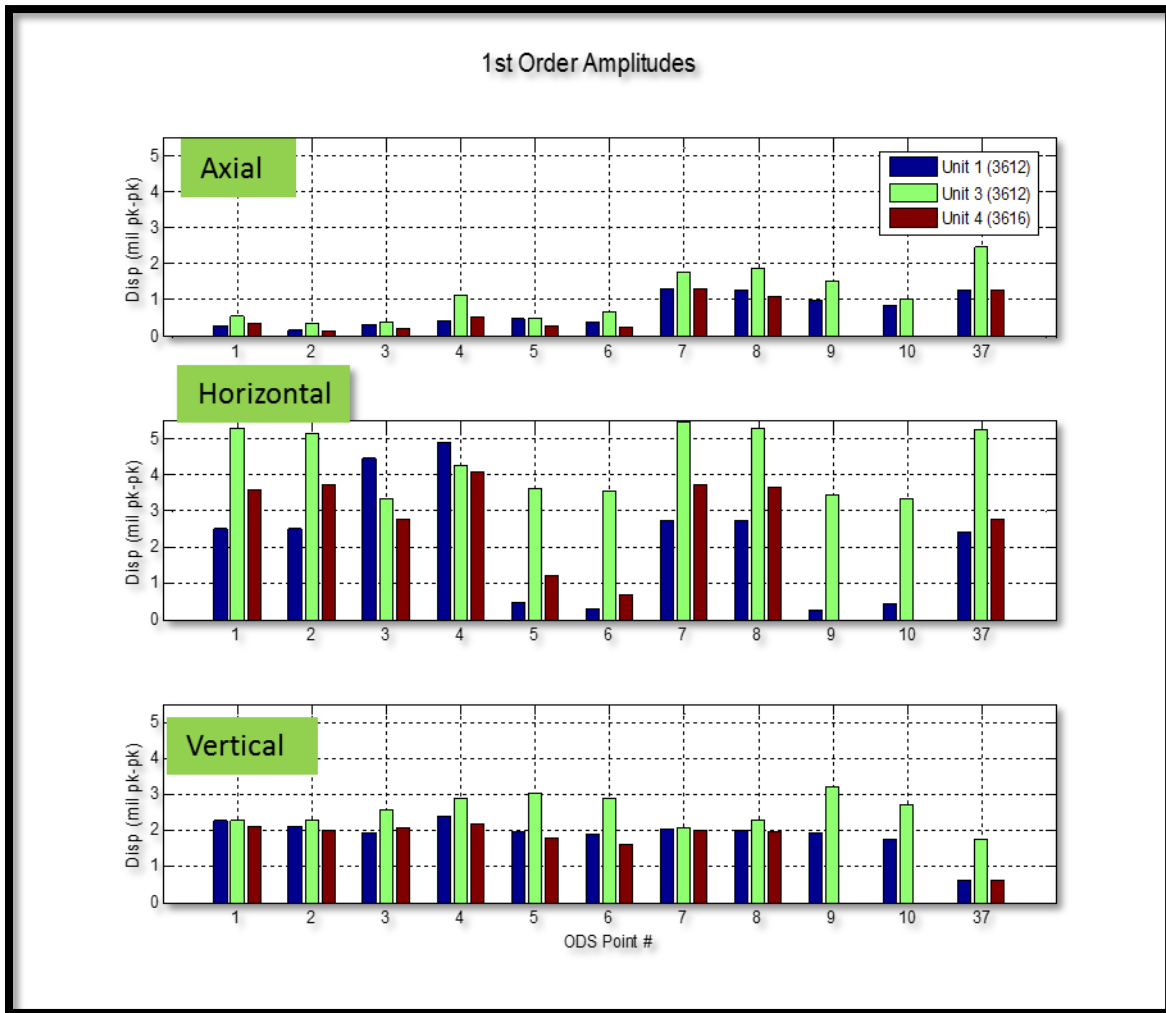
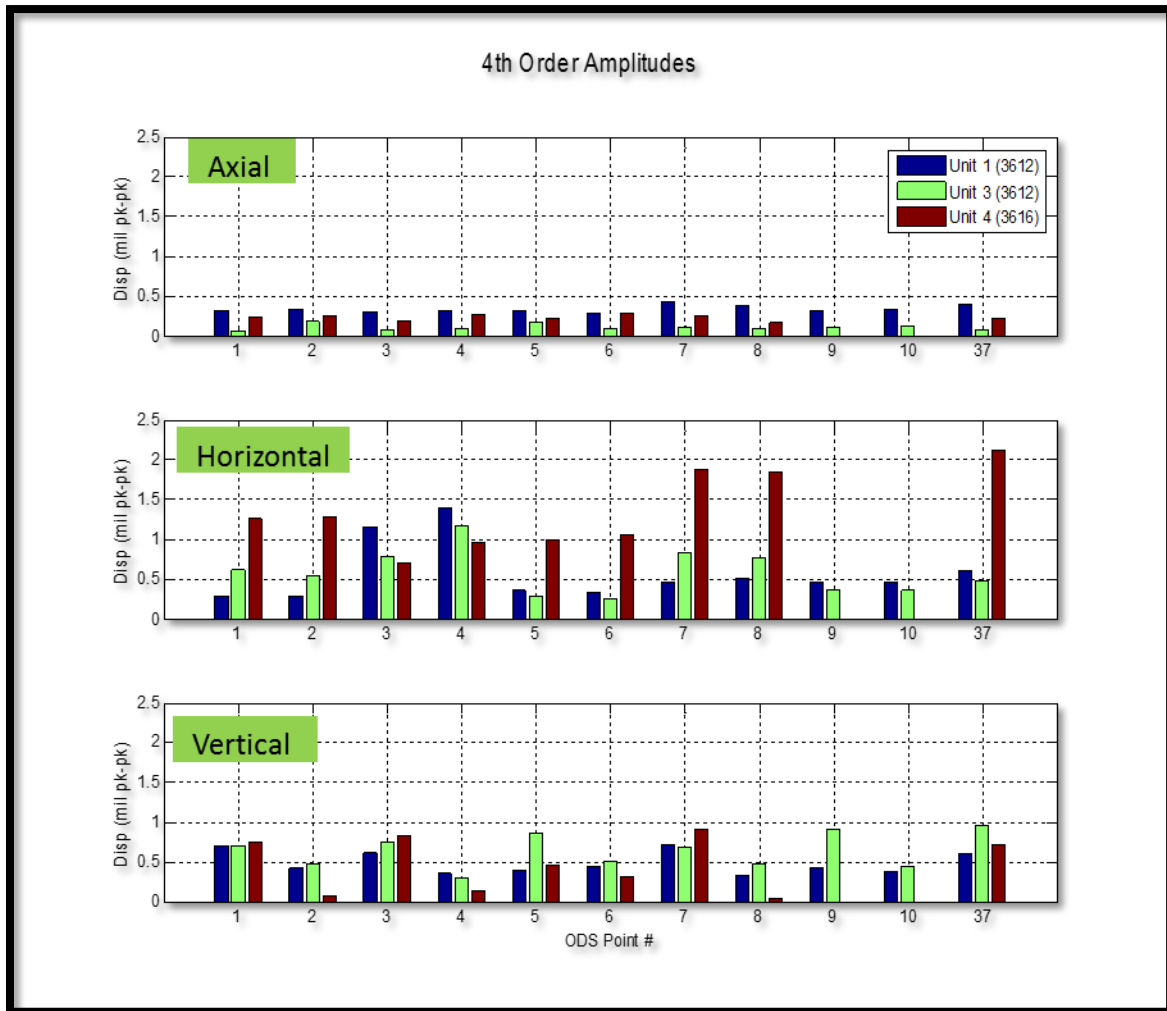
In general, the measurements obtained on three different units indicated that the vibration was not particularly high. The primary vibration was at the 1<sup>st</sup> and 4<sup>th</sup> orders (multiples of engine-compressor speed). Figure 10 shows the 1<sup>st</sup> order vibration for the three units and Figure 11 shows the 4<sup>th</sup> order vibration. Measurements were taken in axial (crank shaft centerline), horizontal (perpendicular to the shaft), and vertical (up and down).

Figure 10: First Order Vibration Measurements on Units 1, 3, and 4

Figure 11: Fourth Order Vibration Measurements on Units 1, 3, and 4

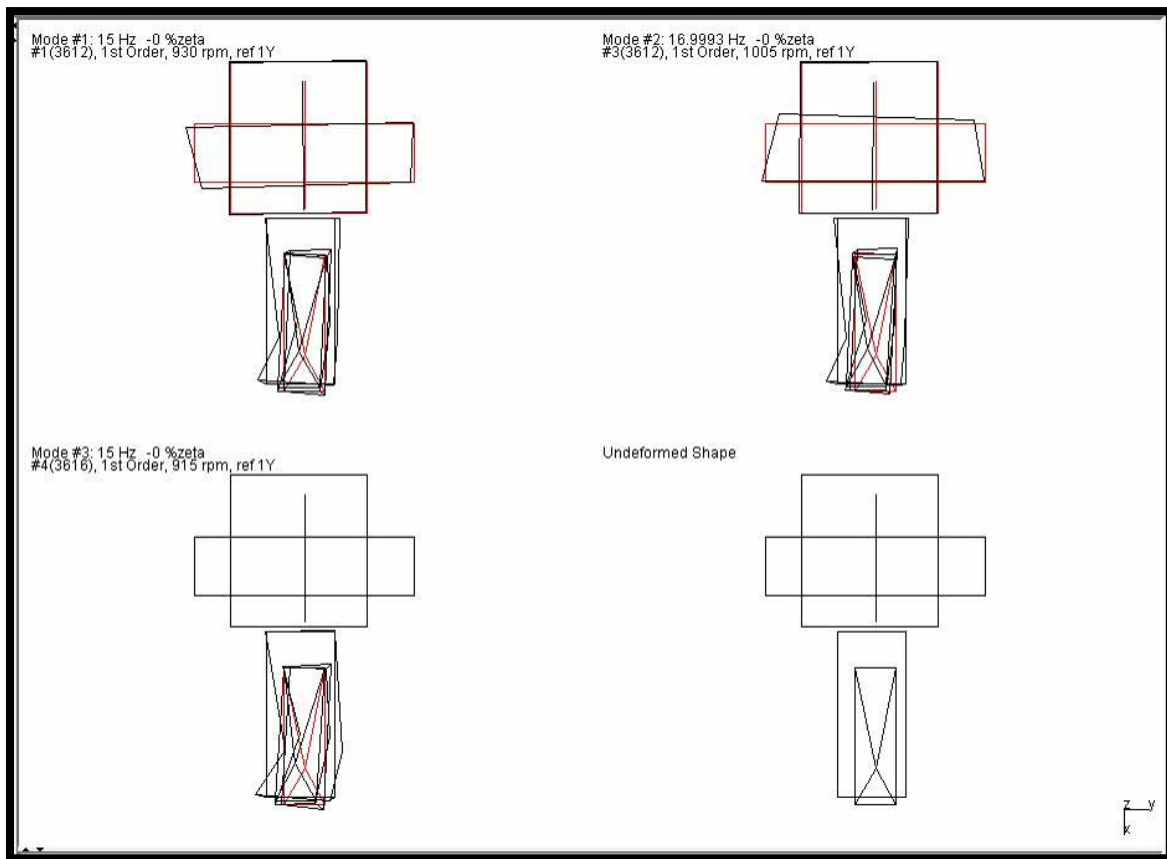
The ODS were computed from vibration data acquired during speed sweeps. Figure 13 shows a top view of the 1<sup>st</sup> order ODS for three slightly different engine speeds. The finite element model was used to determine if this motion could cause a stress pattern consistent with the cracking pattern. Although, some system operating deformation shapes looked like they might be related to the pan cracking, no conclusive “smoking gun” was identified.

Figure 13: Animated ODS Model

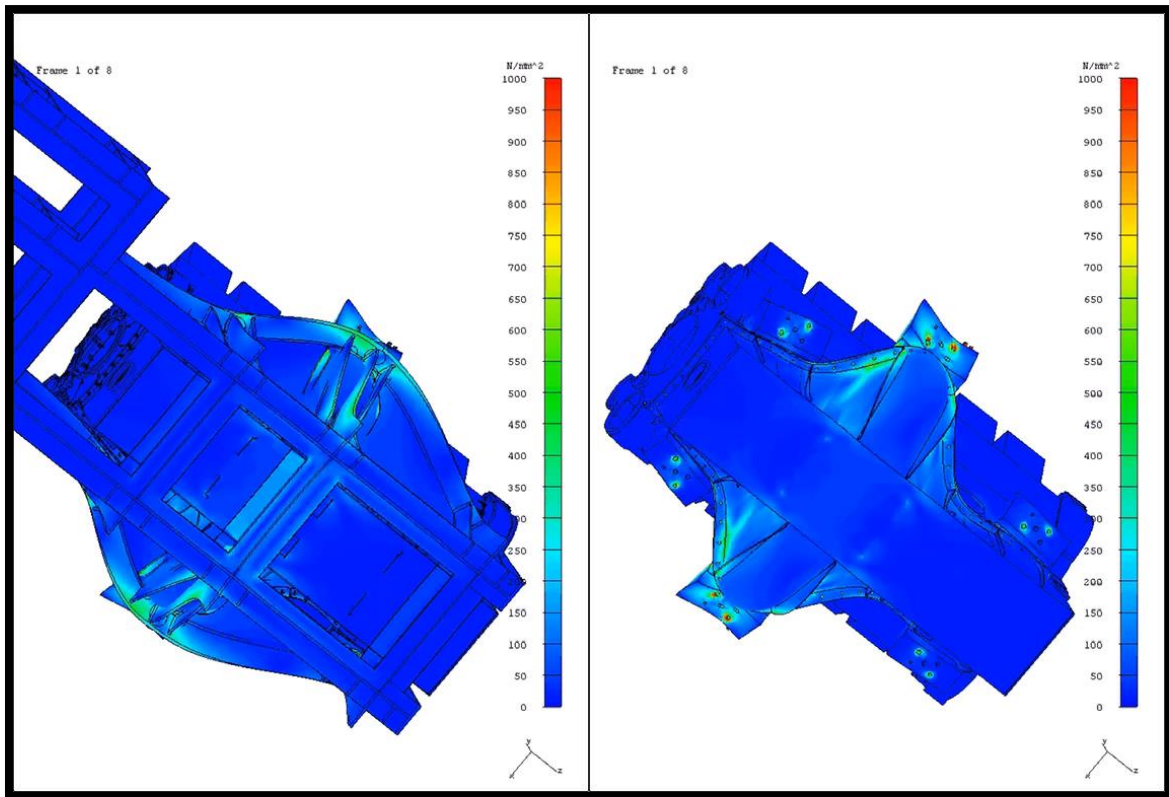
This model was exercised to apply deformations that were measured in the first round of operational testing. The resulting stress patterns did not match the crack pattern, Figure 16. Once again, this indicated that the issue was not system wide and a closer look at the local mode shape was required.

Figure 16: Stress Pattern of CAT 3612 from Operational Test

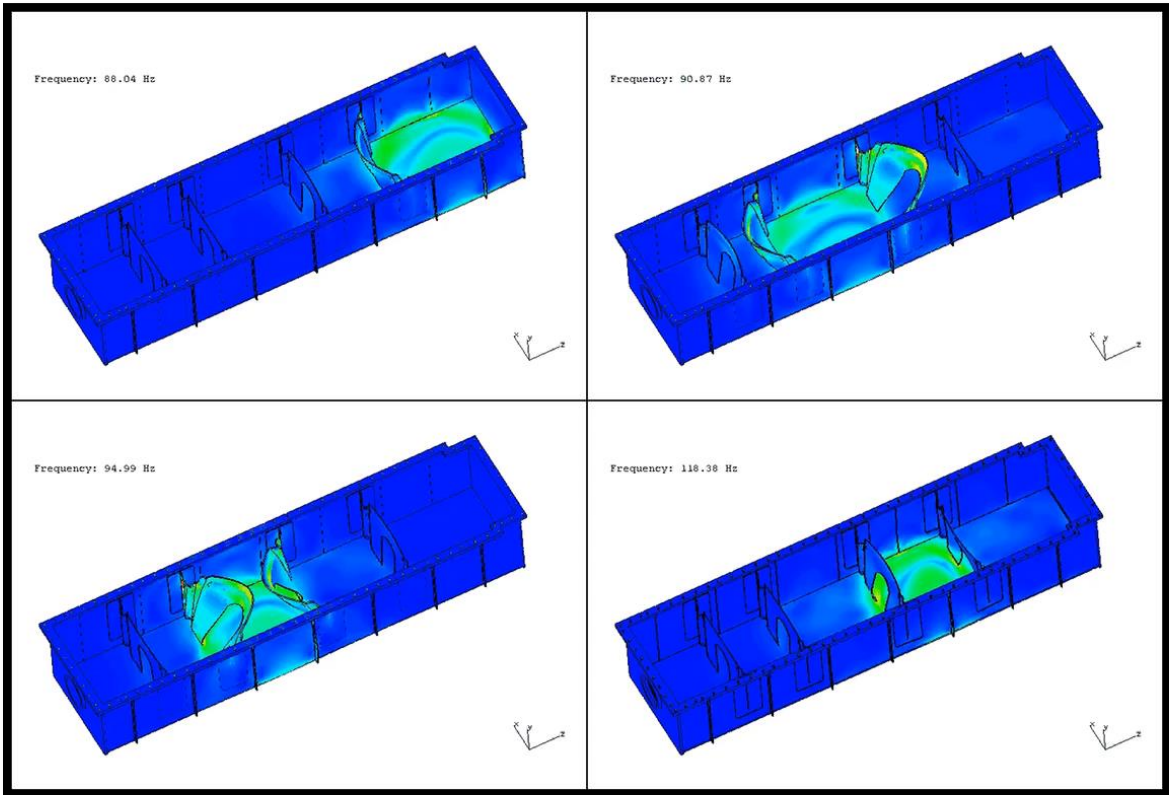
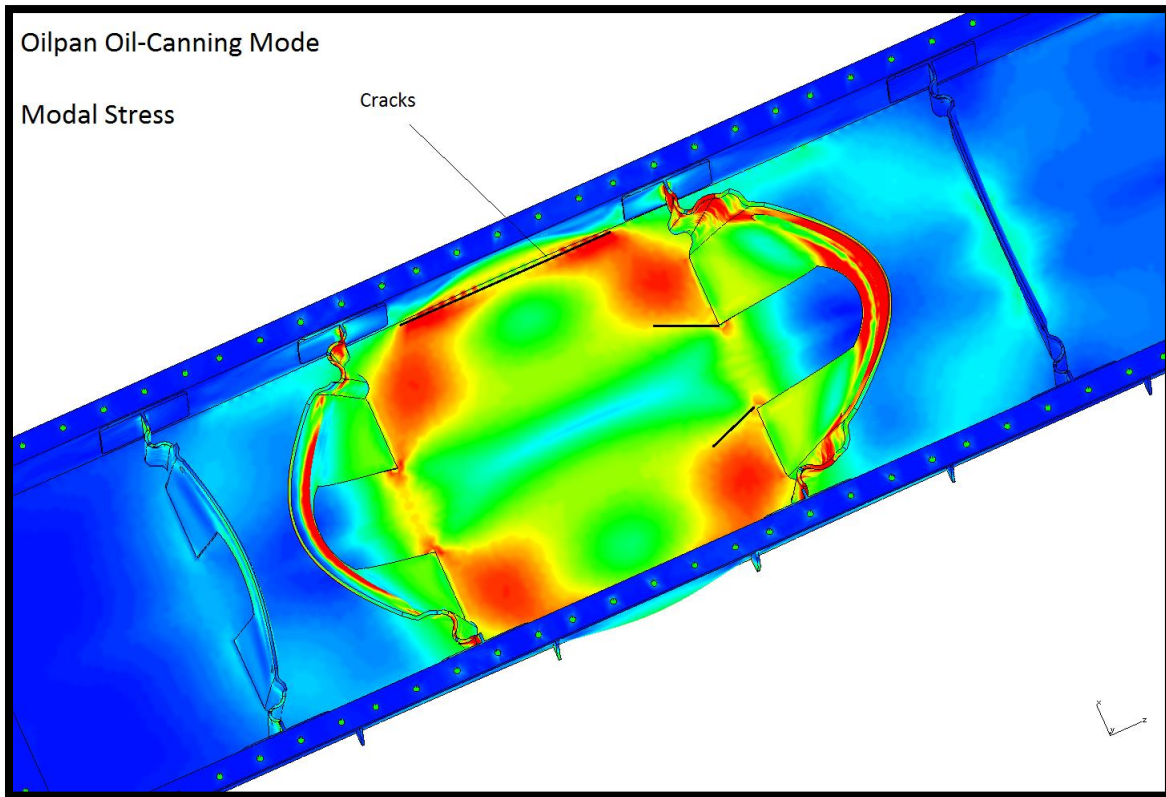
Further work was done on the oil pan to compute the natural frequencies and mode shapes, Figure 17. One of these mode shapes for the largest oil pan bottom panel matched the crack pattern, Figure 18. The FEA results were used to plan strain gauge and accelerometer locations for further testing. However, it was not yet clear why a particular panel was experiencing a problem. All of the panels exhibited vibration modes that could be potentially excited at various engine speeds. Therefore, it was critical to determine the forcing function exciting the mode shapes.

Figure 17: Local Oil Pan-Canning Mode Shapes

Figure 18: Resultant Stresses from Oil-canning Mode

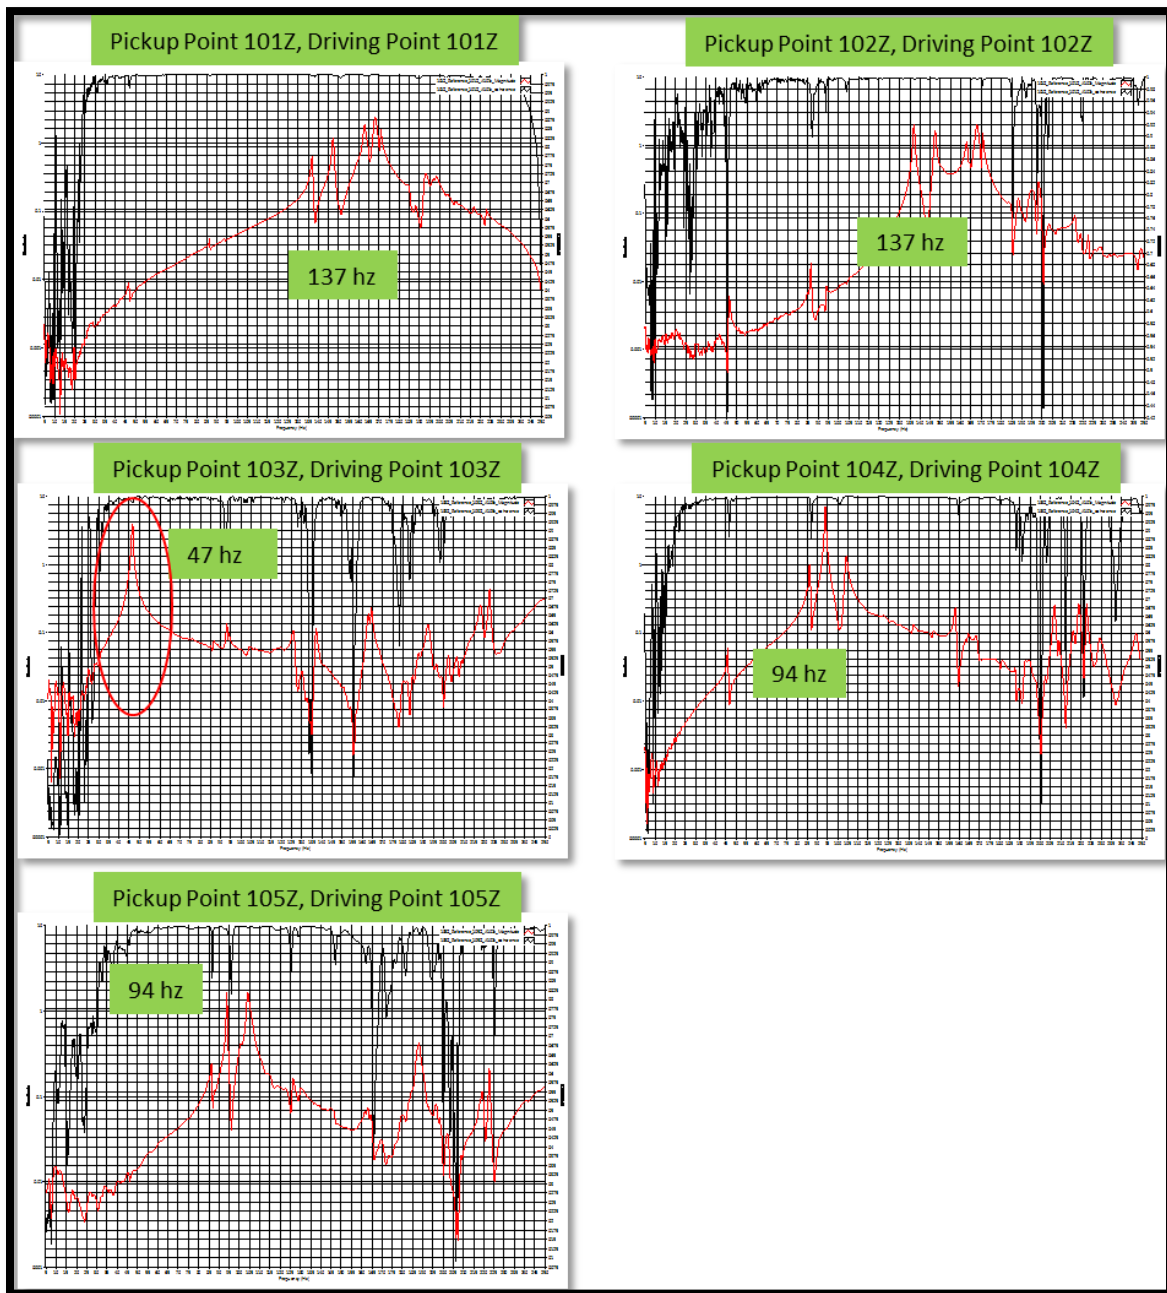
All bottom panel oil canning (1<sup>st</sup> fundamental) natural frequencies agreed with the finite element model results except the panel exhibiting the failures, Figure 21. The measured natural frequency of the subject panel was about half that predicted by the FEA. This indicated that this panel had stiffness that was about 25% of what we expected and helped us to understand why there were times the oil pans arrived on site with the panel buckled.

Figure 21: On-site Oil Pan Modal Impact Data

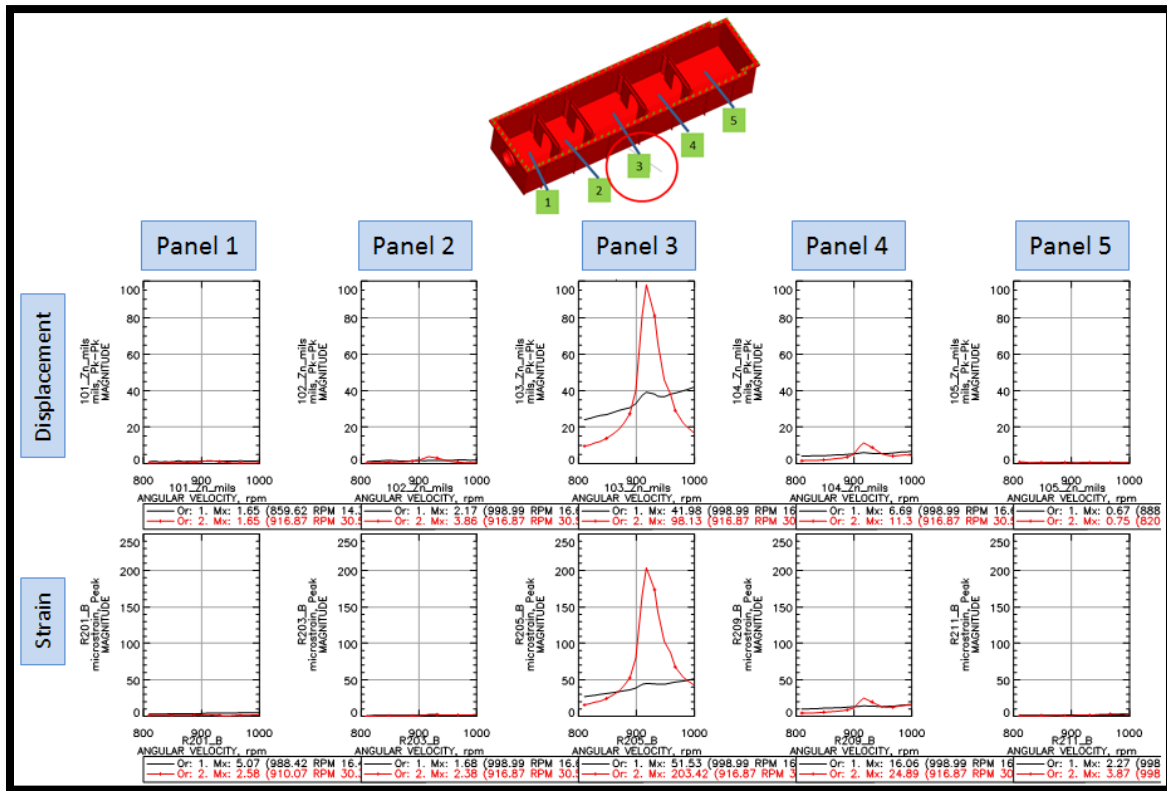
Data was acquired over a full range of engine speeds. This data was processed to provide order tracks of the key engine compressor orders. The key result was that the strain gauges in the failure region showed a strong resonant peak at the 2<sup>nd</sup> order at about 31 Hz (915 rpm). This resonance caused approximately a 10 to 1 strain magnification factor, Figure 23. Obtaining actual strain data (the strain gauges measure the stretching of the steel which can be related to stress and fatigue life) was a very important addition to the vibration measurements. Vibration data cannot be directly related to the internal stresses of a structure but strains can. The vibration natural frequency causing deformation patterns producing high stresses can be identified by the frequency and magnitude of the measured strains.

Figure 23: Displacement and Strain Measurements

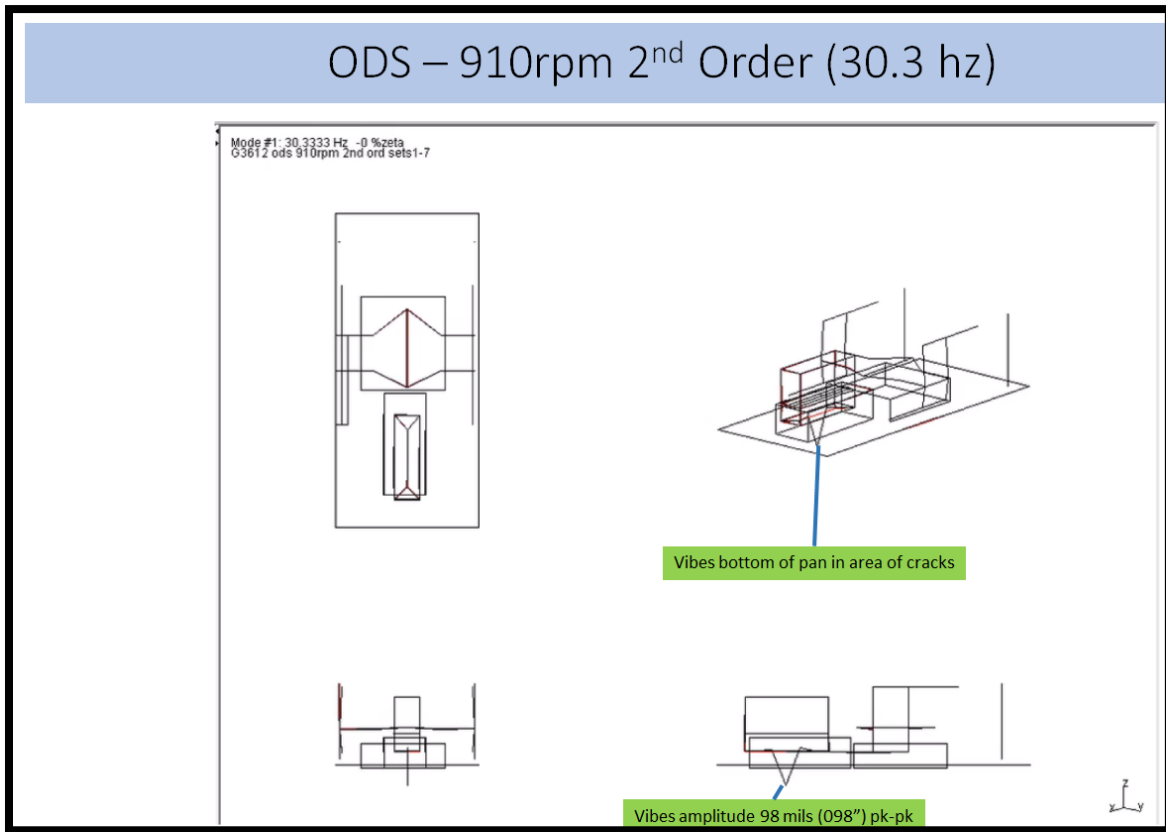
Once again ODS were developed from the vibration survey data. Of interest was the operating deformation shapes developed from the 2<sup>nd</sup> order responses. This ODS pattern confirmed that the oil pan cracking was not due to a system wide resonance, but due to a local resonance of the subject oil pan bottom panel. Figure 24 shows the panel motion standing out compared to the motion of the remaining system.

Figure 24: ODS of Oil-Caning Vibration

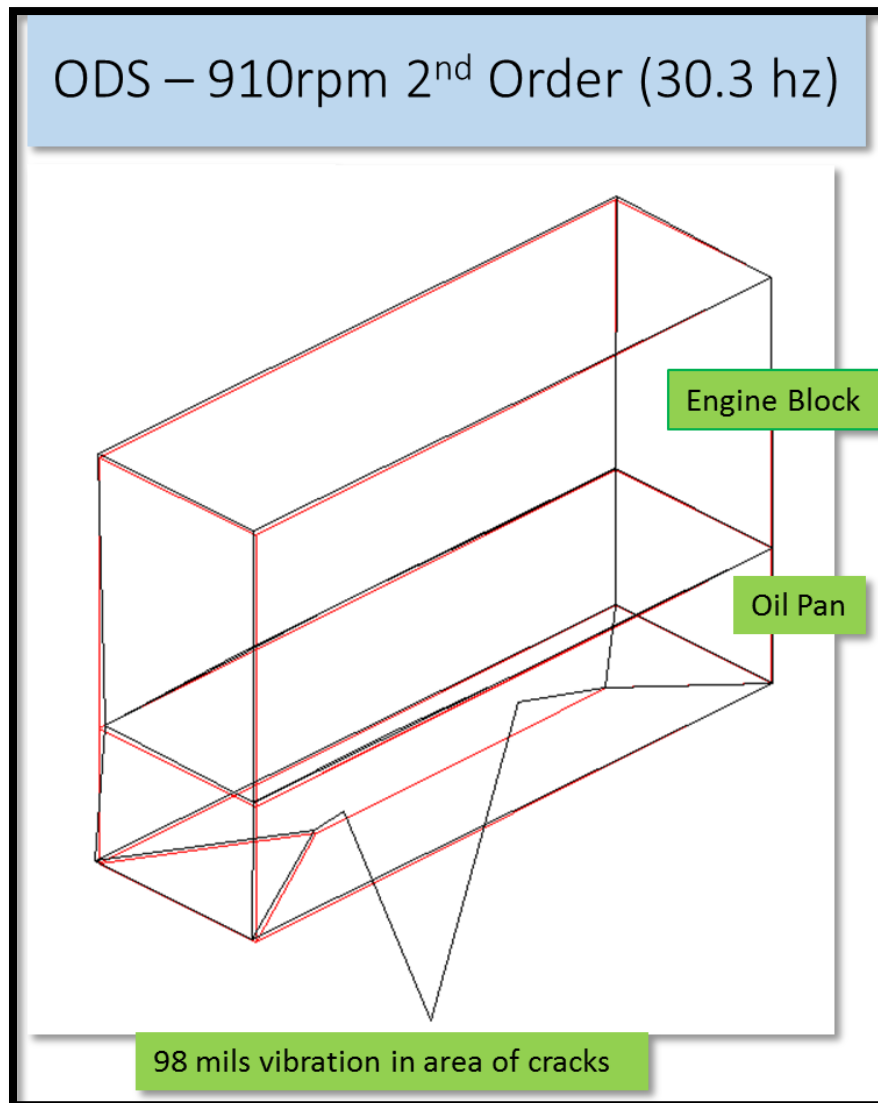
Figure 25 zooms in on the engine block and oil pan providing a more clear view of the subject oil pan panel motion.

Figure 25: Zoomed in View of Oil Pan Panel Motion

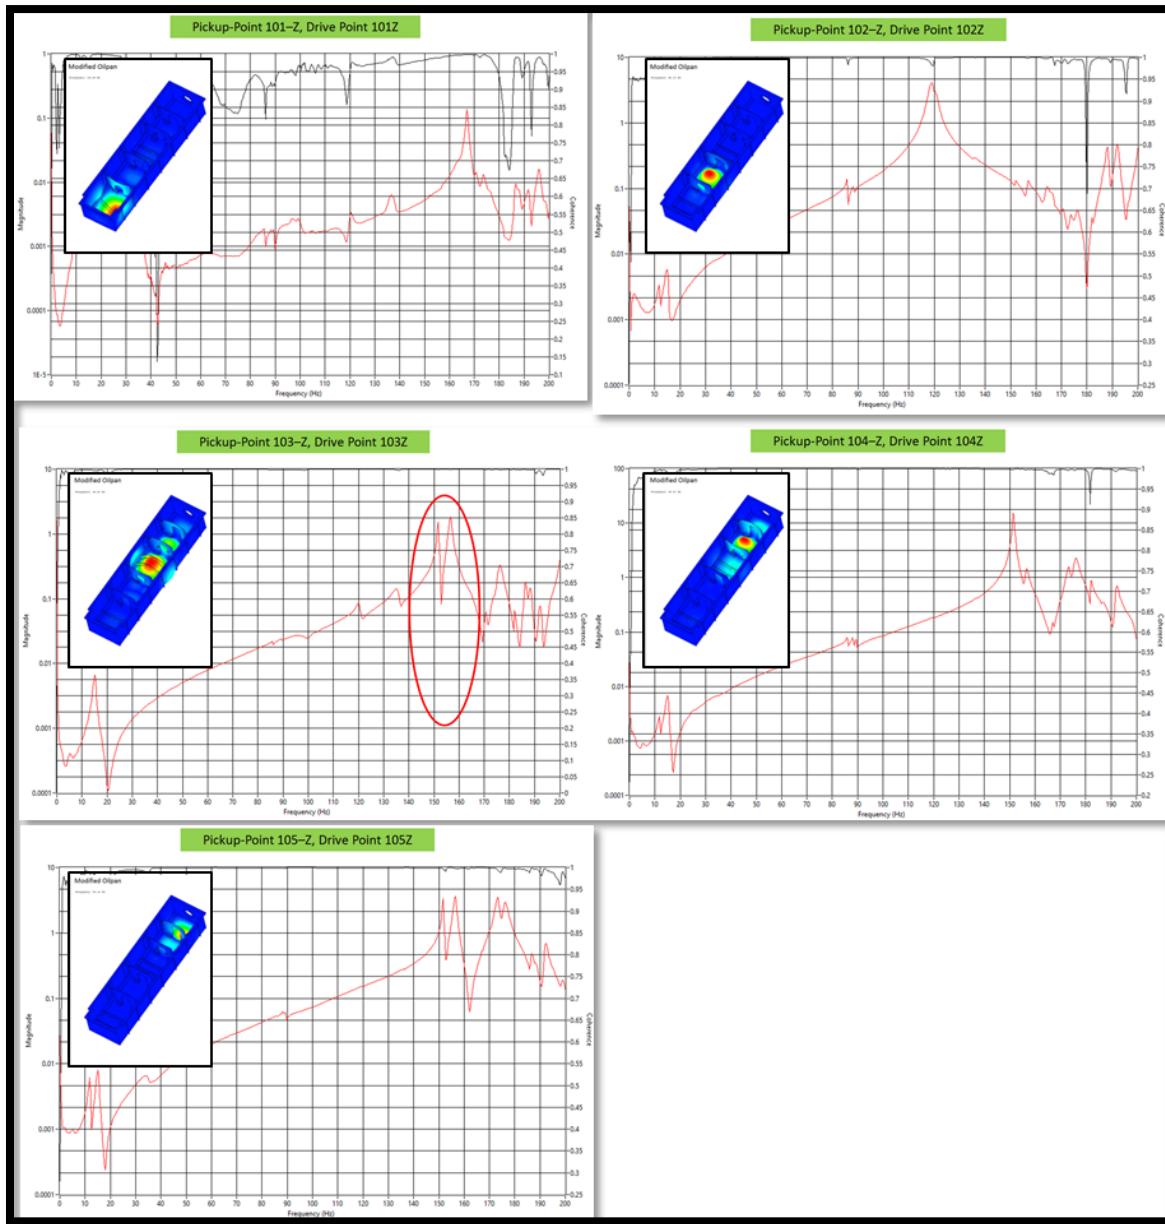
The FEA predicted a substantial increase in natural frequency from 90.3 Hz to 164.3 Hz. The impact testing also indicated a substantial increase in natural frequency from 47 Hz to 135 Hz, Figure 26. This provided confidence that the modified oil pan, when installed in the unit and filled with oil, would provide a sufficient increase in frequency and stiffness to eliminate the cracking problem.

Figure 26: Oil Pan Modal Impact Test After Modification

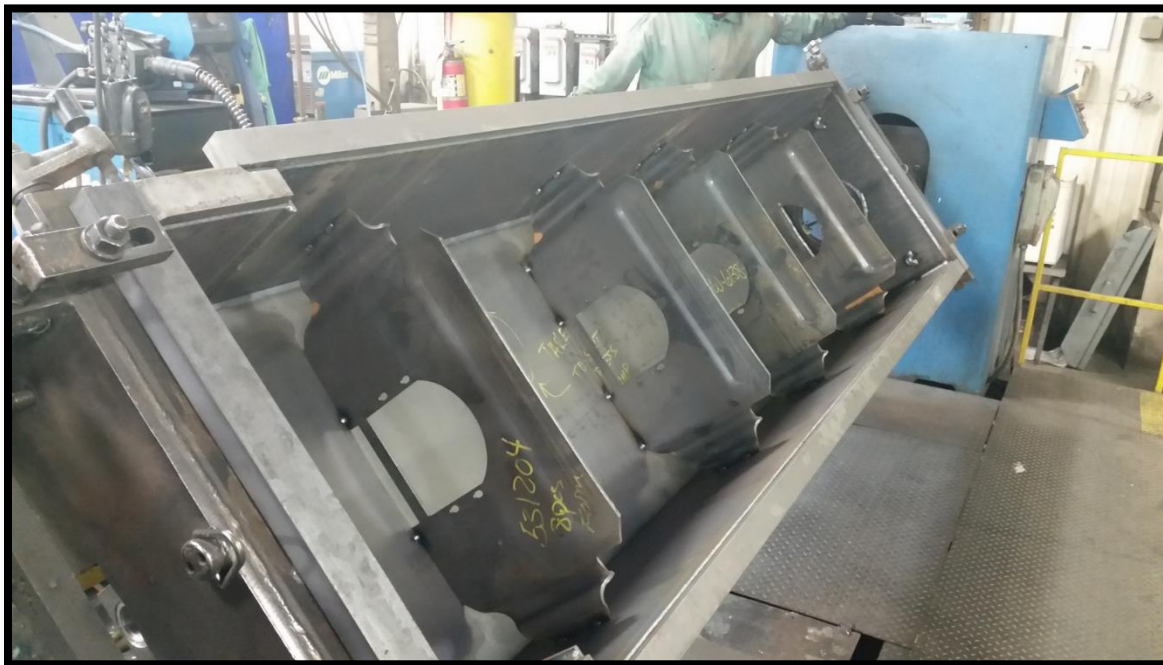
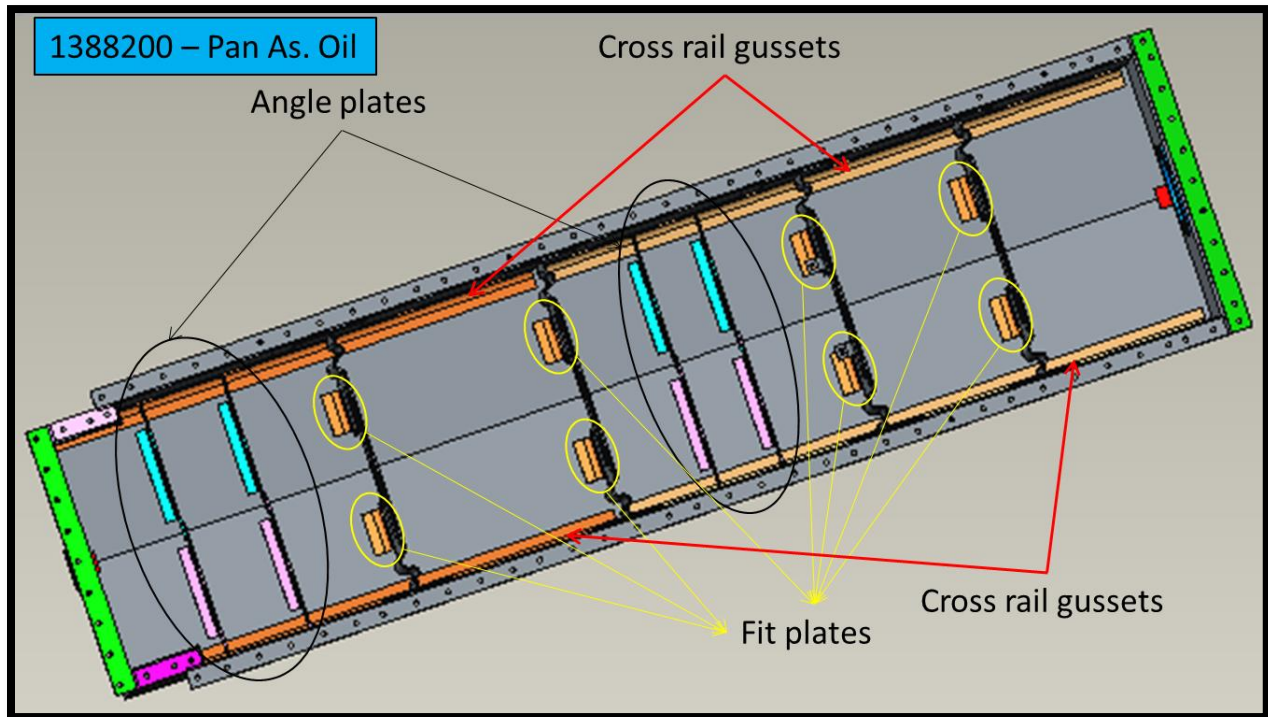
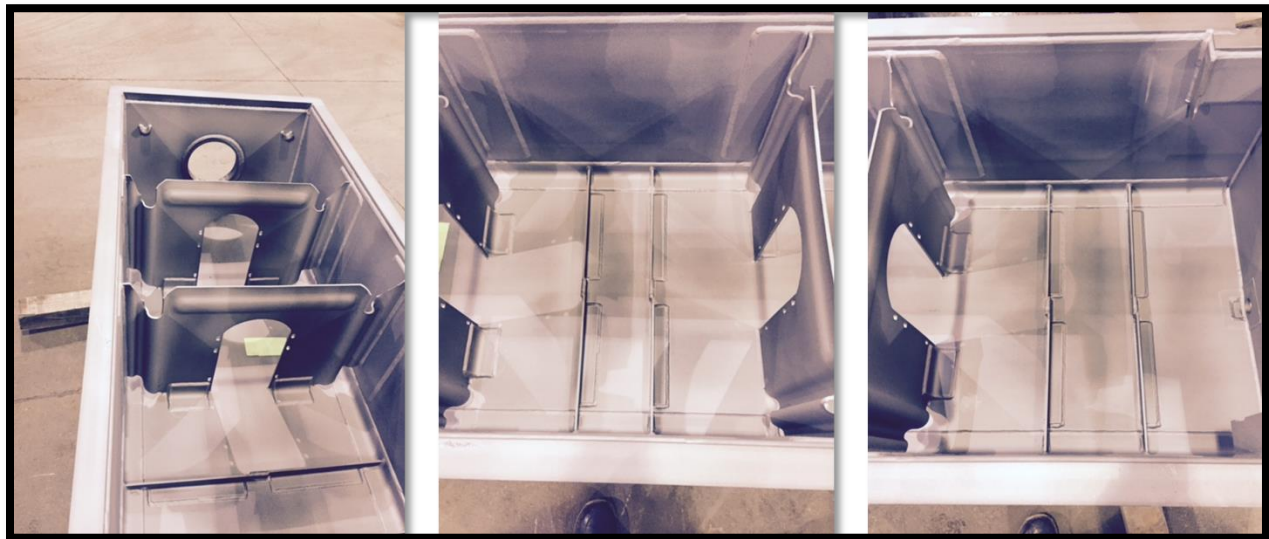
Figure 27: Original Oil Pan

As shown, the original oil pan (Figure 27) was modified to include internal ribs, gussets, and fit plates to increase the natural frequency of the subject panel, Figure 28 and Figure 29. This additional stiffness moved the mode above the 2<sup>nd</sup> order forcing frequency. The validation test of the oil pan alone showed that the natural frequencies and stiffness were increased sufficiently to prevent future fatigue failures. This provided sufficient confidence in the solution that an installed, instrumented test of the oil pan would not be necessary.

Figure 28: Oil Pan Design with Angle Plates, Fit Plates, and Cross Rail Gussets

Figure 29: Final Oil Pan with Additional Stiffness and Support in Key Areas
