# **Case Study: How Recurring Oil Pan Cracks on Large High Speed Gas Engines were Investigated and Resolved**

2015 Gas Machinery Conference

The following case study illustrates issues with oil pans developing cracks shortly after being put into service on large, high-speed gas engines. Cracks developed on the bottom of several Williams' engine oil pans in late October 2014 after accumulating no more than 70 hours of run time. This prompted Williams, Caterpillar, and 6D Testing & Analysis to identify suspect oil pans and initiate an investigation. The process taken to identify the cause of the oil pan cracks including the details of the investigation, analyses, and test results are described in the following paper.

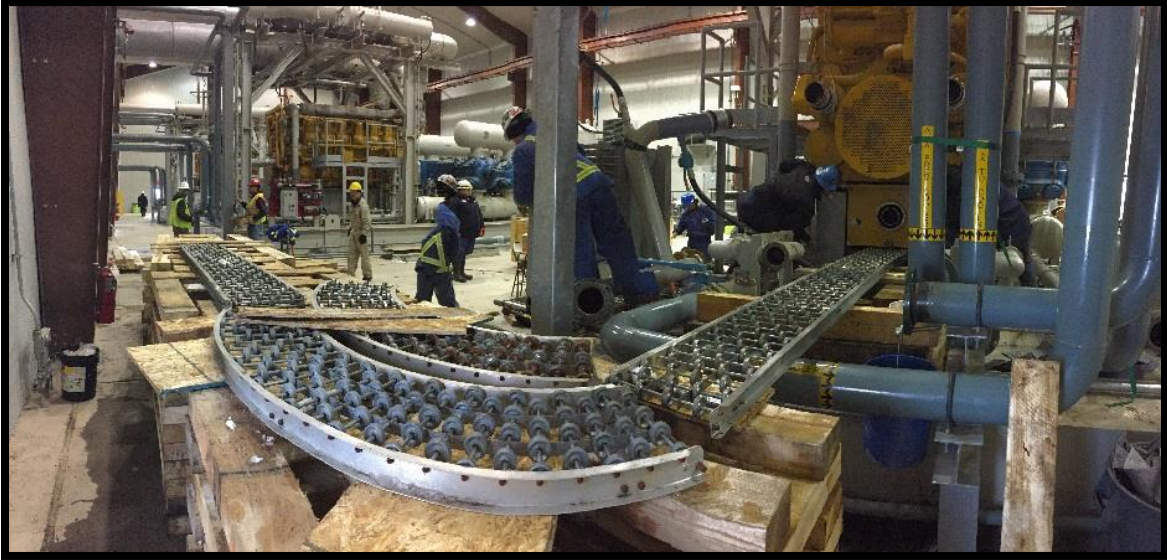
Figure 4: Roller Track used to Remove Oil Pan from Engine

The process of removing an oil pan from a large high-speed engine is not a typical procedure and requires special precaution and cribbing in order to maintain the integrity of the pan for later examination. Photos of the procedure are shown in Figure 4 and Figure 5.

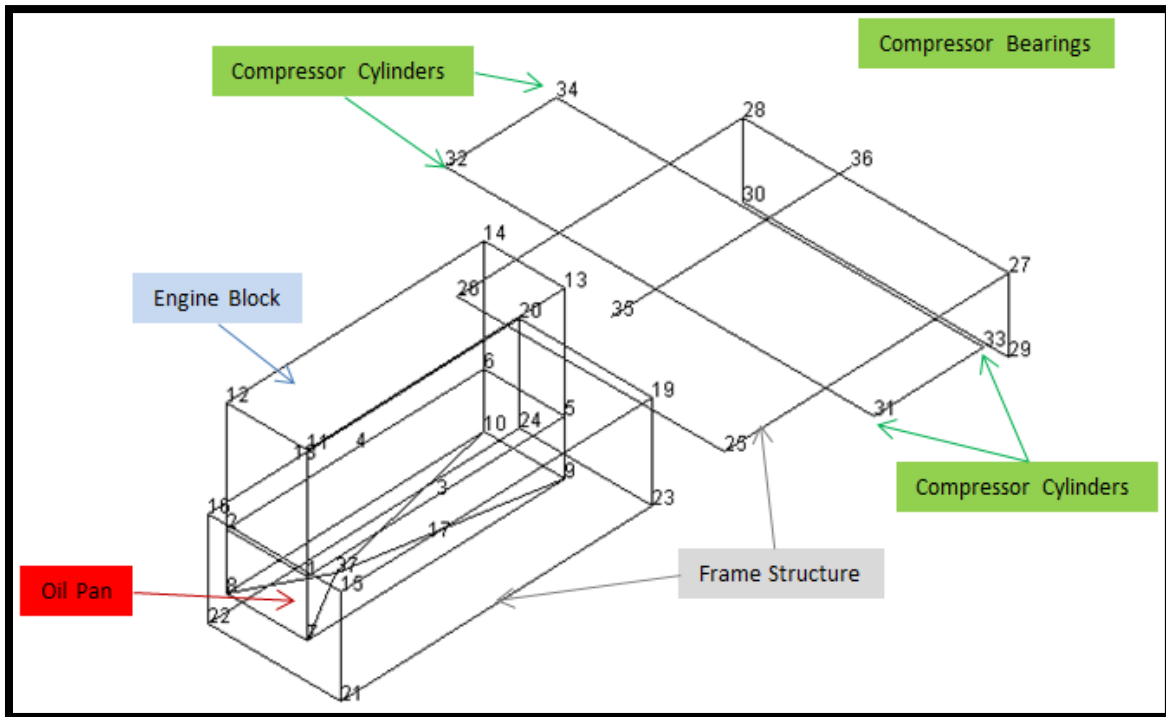
Figure 12: ODS Model of CAT 3612 and Compressor

The ODS were computed from vibration data acquired during speed sweeps. Figure 13 shows a top view of the 1<sup>st</sup> order ODS for three slightly different engine speeds. The finite element model was used to determine if this motion could cause a stress pattern consistent with the cracking pattern. Although, some system operating deformation shapes looked like they might be related to the pan cracking, no conclusive “smoking gun” was identified.

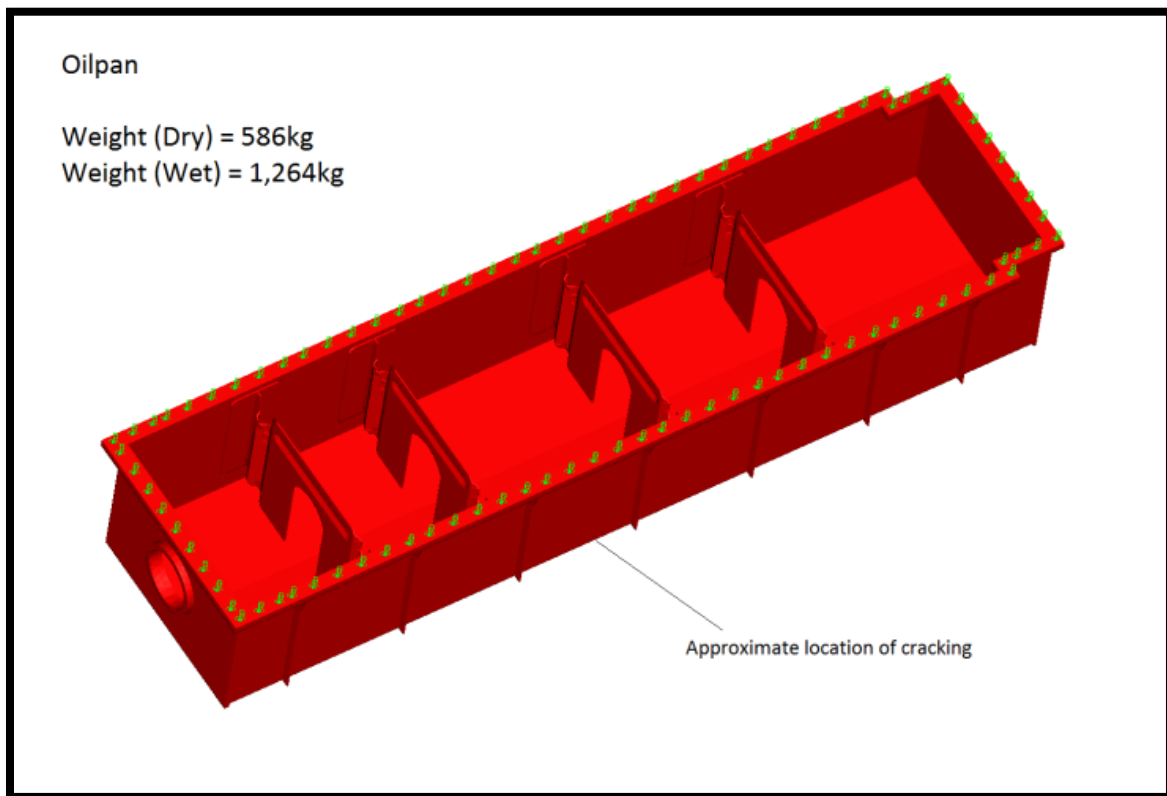
Figure 14: Detailed FEM of Oil Pan

A finite element model of the oil pan, Figure 14, was developed and incorporated in an overall finite element model of the engine compressor system, Figure 15.

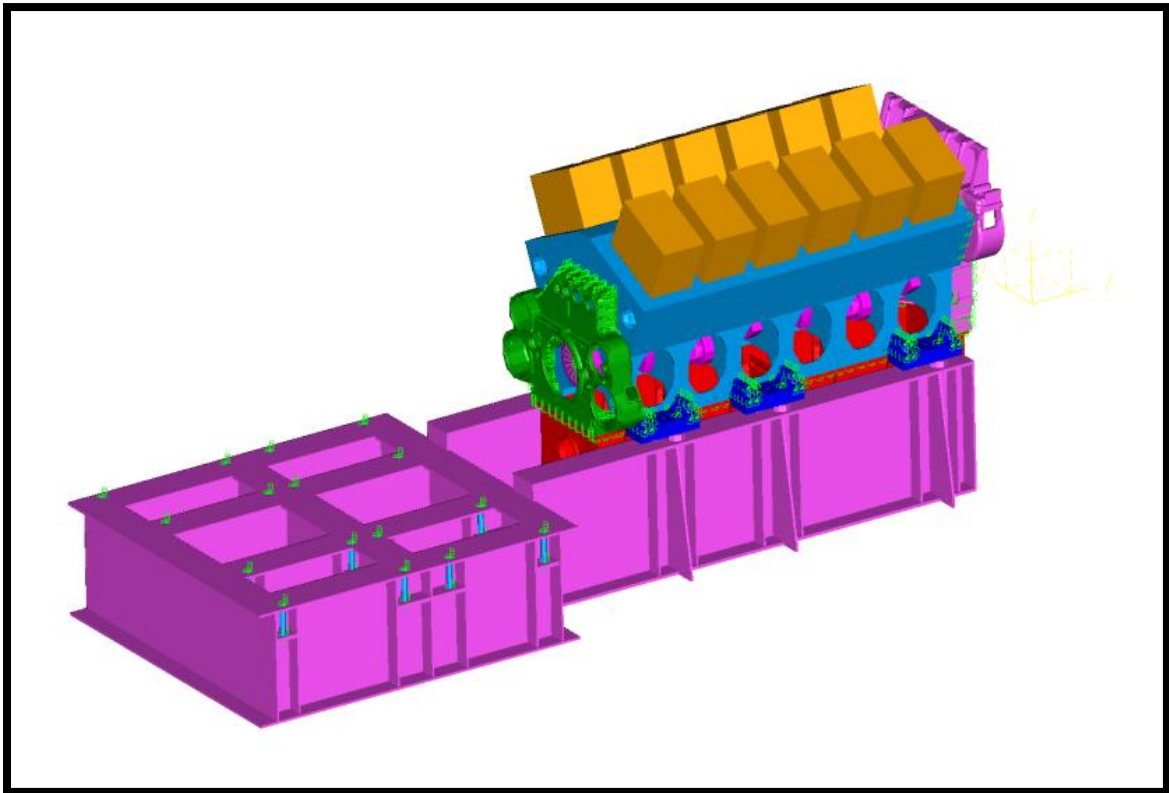
Figure 15: Finite Element Model of a CAT 3612

This model was exercised to apply deformations that were measured in the first round of operational testing. The resulting stress patterns did not match the crack pattern, Figure 16. Once again, this indicated that the issue was not system wide and a closer look at the local mode shape was required.

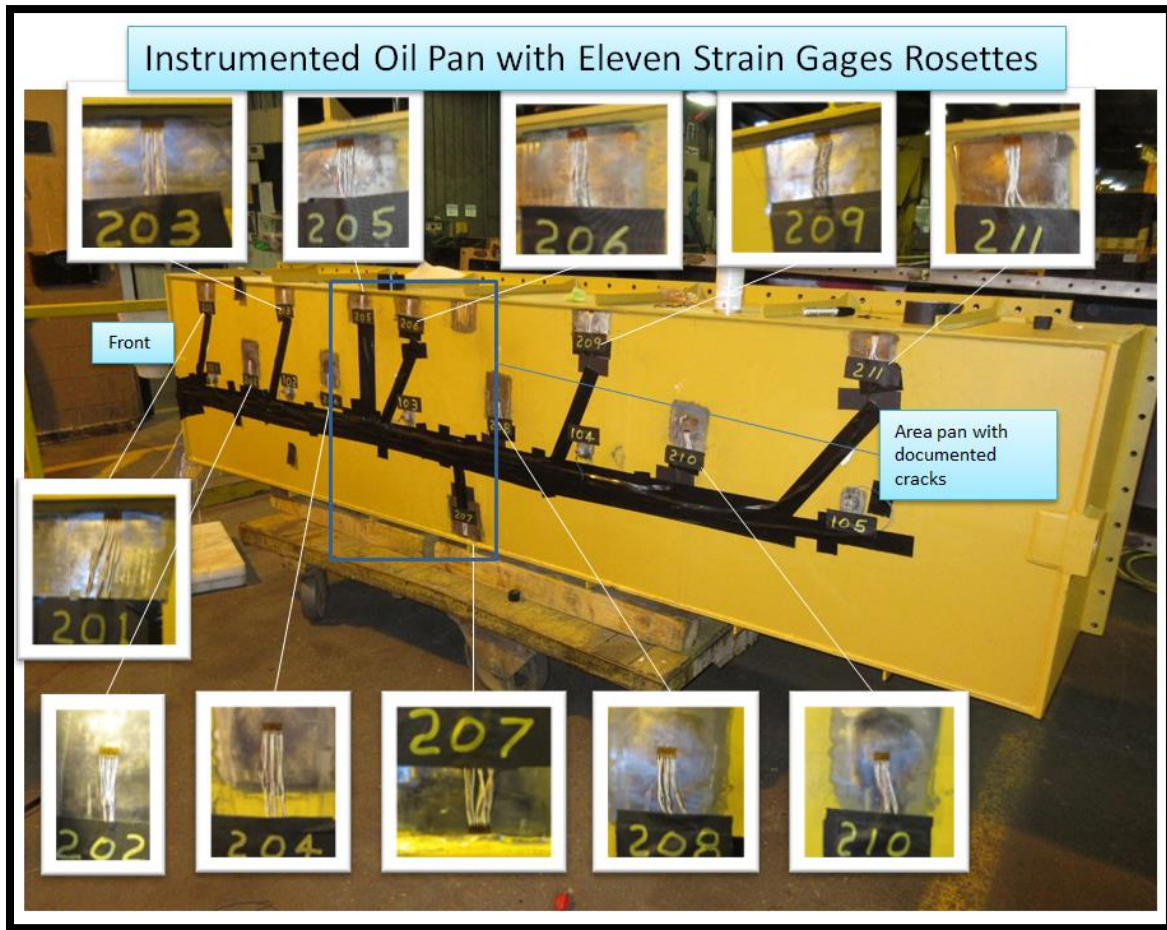
Figure 19: Strain Gauge Locations on the Oil Pan

Figure 19 shows the locations on the oil pan where strain gauges were installed. The strain gauges contain a fine wire array bonded to the steel that measure the stretching of the steel by very small resistance changes in the wire. This measured strain is proportional to the resistance produced which can be converted into stresses and related to fatigue life.

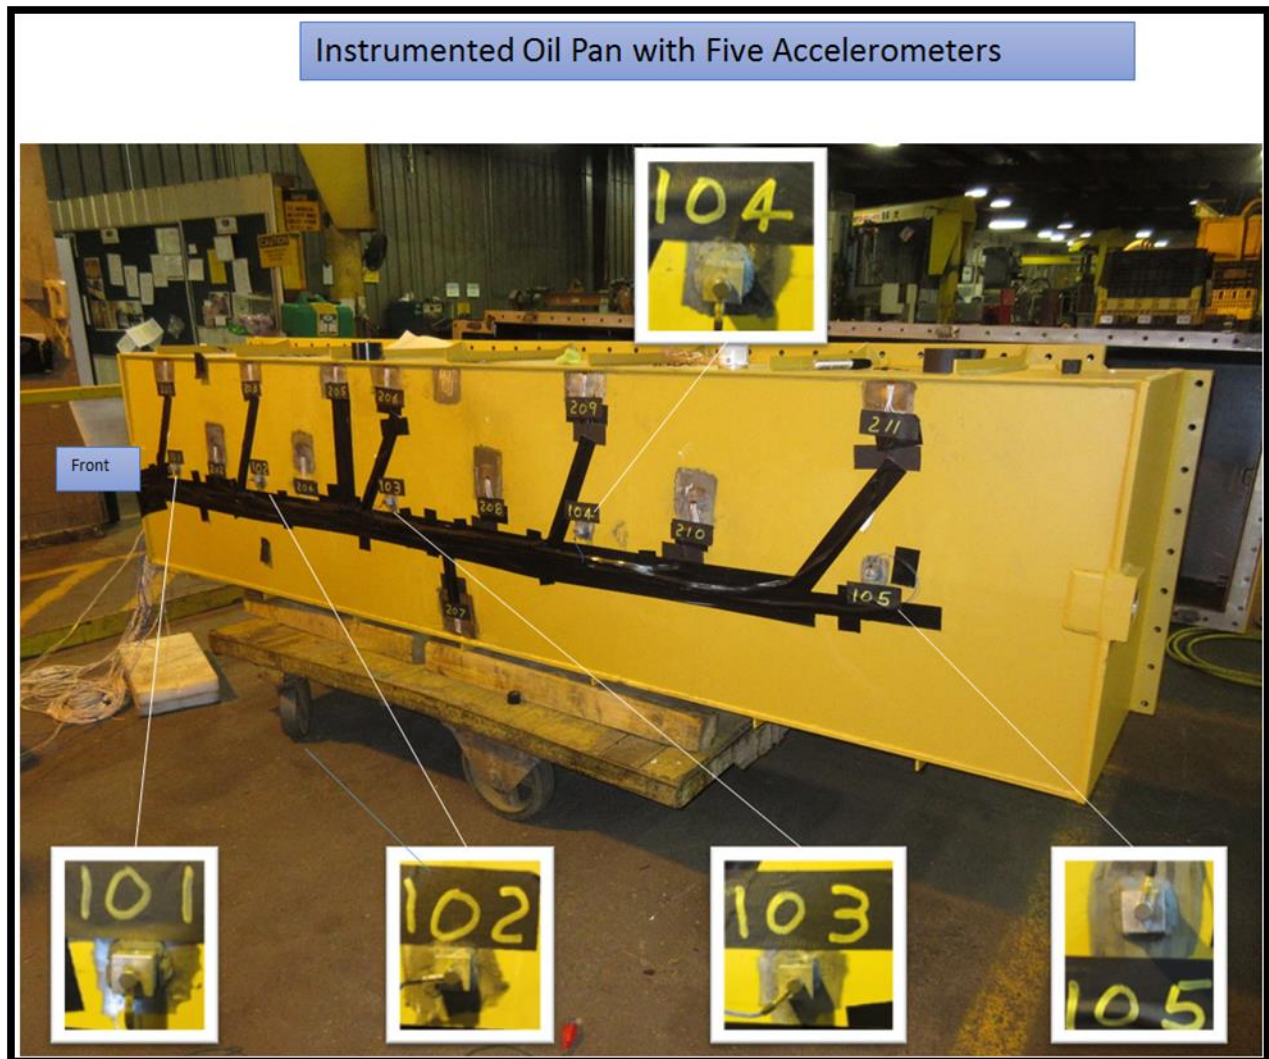
Figure 20: Accelerometer Locations on the Oil Pan

Figure 20 shows locations on the bottom of the oil pan where accelerometers were installed. Each of the five accelerometers were placed at the center of a panel. Although the bottom of the oil pan was a continuous steel sheet, the bottom of the oil pan could be divided into five somewhat independent panels due to the internal baffles and supports.

All bottom panel oil canning (1<sup>st</sup> fundamental) natural frequencies agreed with the finite element model results except the panel exhibiting the failures, Figure 21. The measured natural frequency of the subject panel was about half that predicted by the FEA. This indicated that this panel had stiffness that was about 25% of what we expected and helped us to understand why there were times the oil pans arrived on site with the panel buckled.

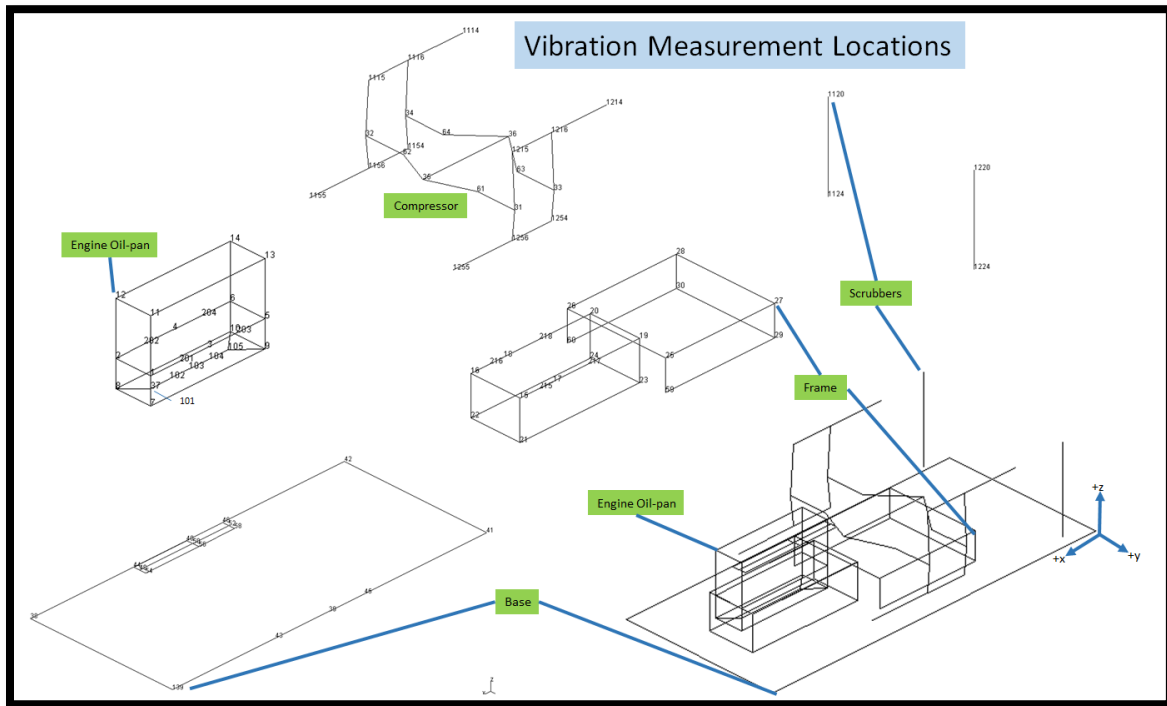
Figure 22: ODS Model of All Measurement Locations

More detailed vibration measurements were made on the compressor, engine, base, and piping structures in order to more thoroughly search for any system level root causes for the oil pan cracking. Figure 22 illustrates the larger array of measurement points used in this round of testing.
